TURBOMAX BLOWER INTRODUCTION

氣浮式鼓風機技術

今日水處理設備有限公司
報告人：陳勝隆0933-185503

2020V2

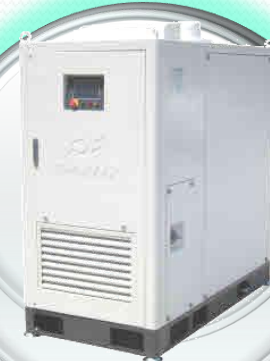
Air Bearing
Turbo Blower

The Turbo Blower is a device generating compressed air using an applied air bearing, impeller, high speed motor, inverter and controller connected to a robust centrifugal turbine located directly on a permanent magnet **Synchronous** motor driven by the inverter.

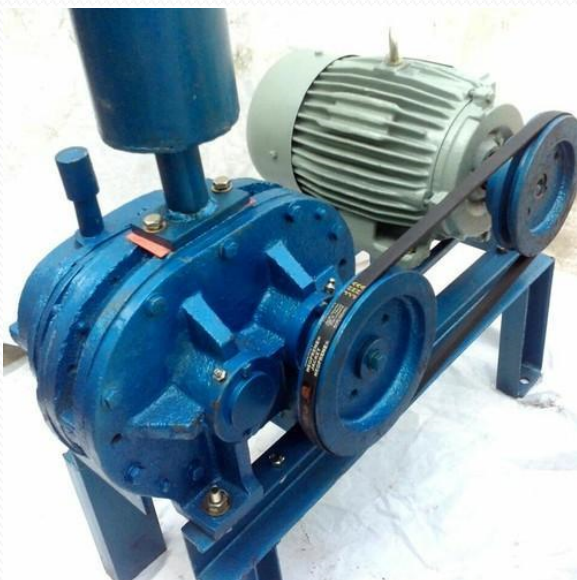
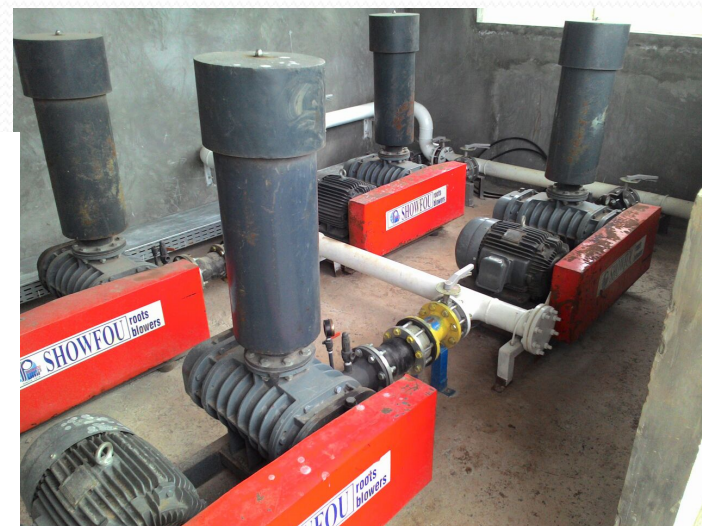
能量傳遞精簡使效能極大化

從馬達到壓縮空氣為一體化構造，使能量傳遞損失降至最低；藉由無接觸式運轉，幾乎不需要維護；模組化系統直接由代理商進行服務。

能量傳遞七階段 (傳統魯式鼓風機)

能量傳遞僅需四階段 (氣浮式鼓風機)

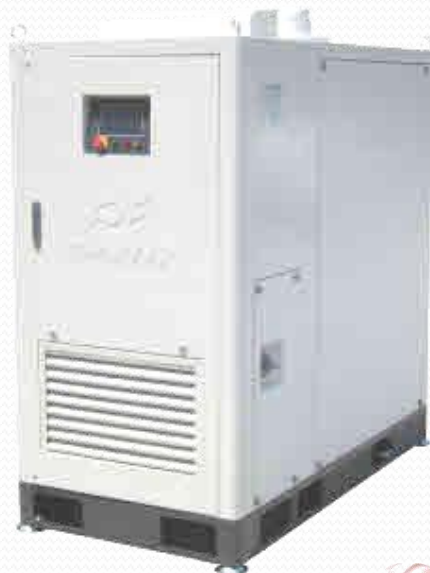
氣浮式鼓風機構造

Mechanical

BOV
(Blow-off Valve)

Main Body

Control

Controller

Electrical panel

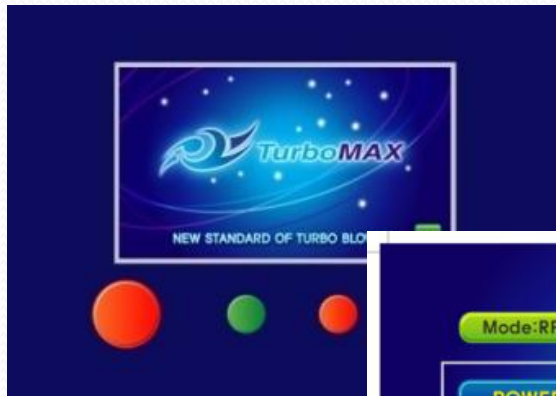
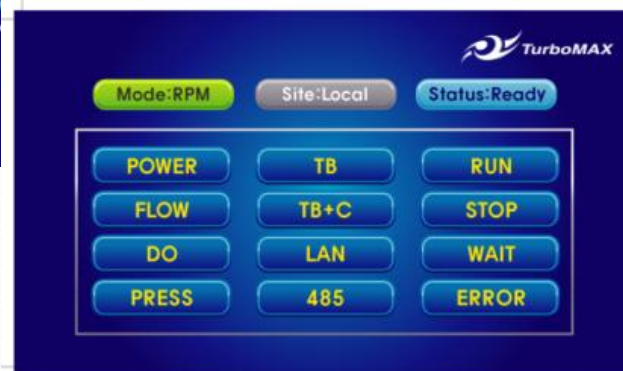
Core Technology (Controller)

- Direct control of **flow/ pressure** possible through rpm and torque adjustment using high speed motor and inverter. Digital remote control and monitoring is optional.
- Auto Flow Mode
- Auto Power Mode
- Auto RPM Mode
- DO-Link Mode
- Failure Check & Reset

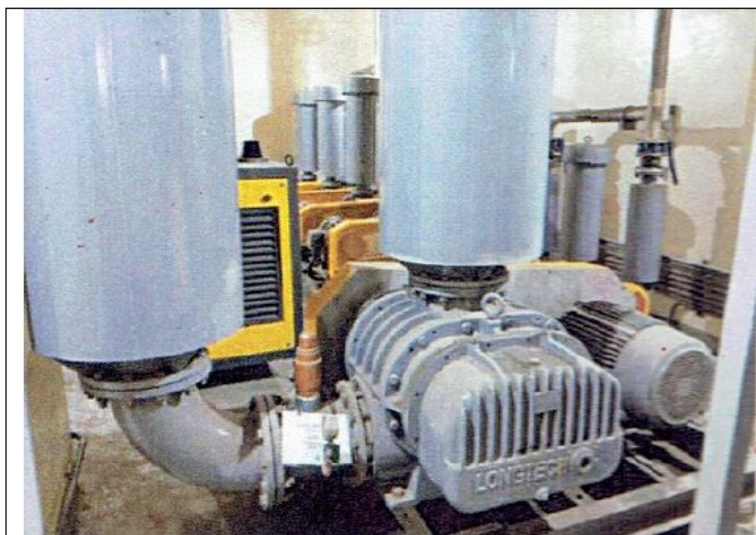
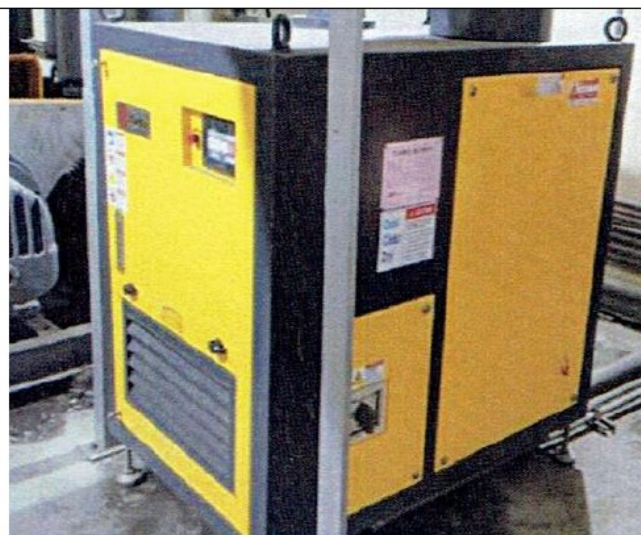
案例廠改善前及改善後照片

改善前(魯式鼓風機)

改善後(氣浮式鼓風機)

- 案例廠為國內大型電子廠，目前廢水處理程序曝氣池設置鼓風機，供應曝氣池適當之空氣量，以維持微生物的好氧性分解能力。廠內目前設有1 台 40HP 魯式鼓風機(改善前)及 1 台 40HP 氣浮式鼓風機(民國 107 年新設置)，平常僅開啟 1 台鼓風機使用。針對 2 台不同鼓風機應用在曝氣池之耗能情形進行比較：
- 完工時間：民國107 年
- 效益評估：
2 台鼓風機規格分別如下所示，因在不同的水池曝氣狀況下，其效益不同，以下分別說明量測評估方式。

- A. 節能量：140,160 kWh/年(因整年度不停機以 8,760 小時/年計算)
(34.2 kW -18.2 kW)× 8,760 小時/年=140,160 kWh/年
- B. 節能率：約 46.8%
- C. 節能效益：約 42 萬元/年(以電價3 元/度、140,160 度/年計算)
- D. 減碳量：約 74.7 公噸CO₂e/年
(以經濟部能源局公告之107 年電力排放係數0.533 kg CO₂e/kWh 計算)

- A. 節能量：87,600 kWh/年(因整年度不停機以8,760 小時/年計算)
(41.3 kW -31.3kW)× 8,760 小時/年=87,600 kWh/年
- B. 節能率：約 24.2%
- C. 節能效益：約 26.2 萬元/年(以電價3 元/度、87,600 度/年計算)
- D. 減碳量：約 46.7 公噸CO₂e/年
(以經濟部能源局公告之107 年電力排放係數0.533 kg CO₂e/kWh 計算)

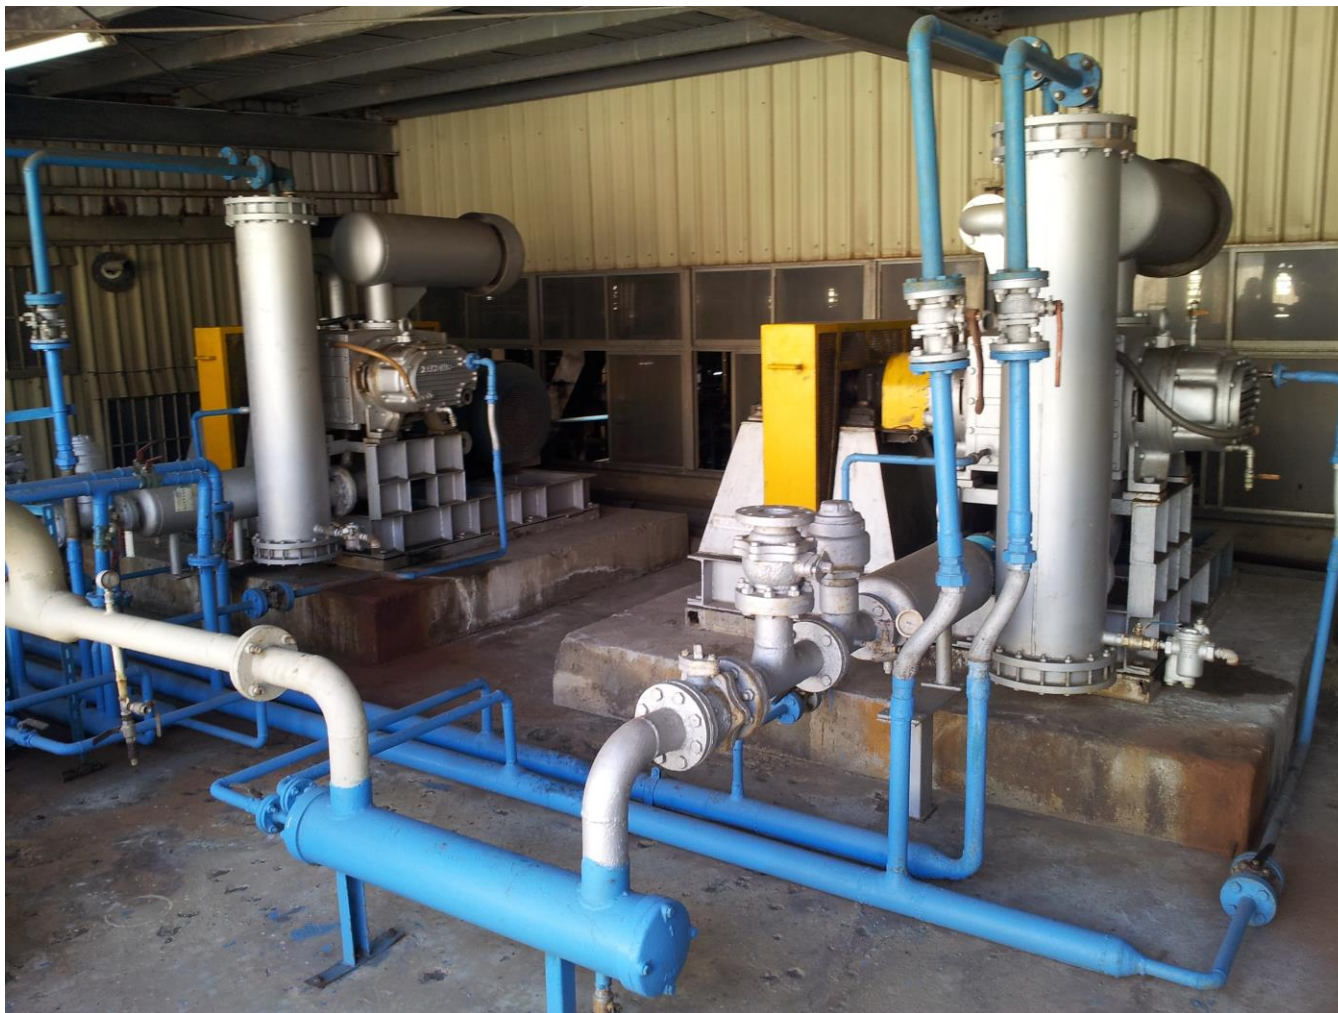
既有魯式鼓風機，需同時運轉300HP才可供應廢水廠需求風量

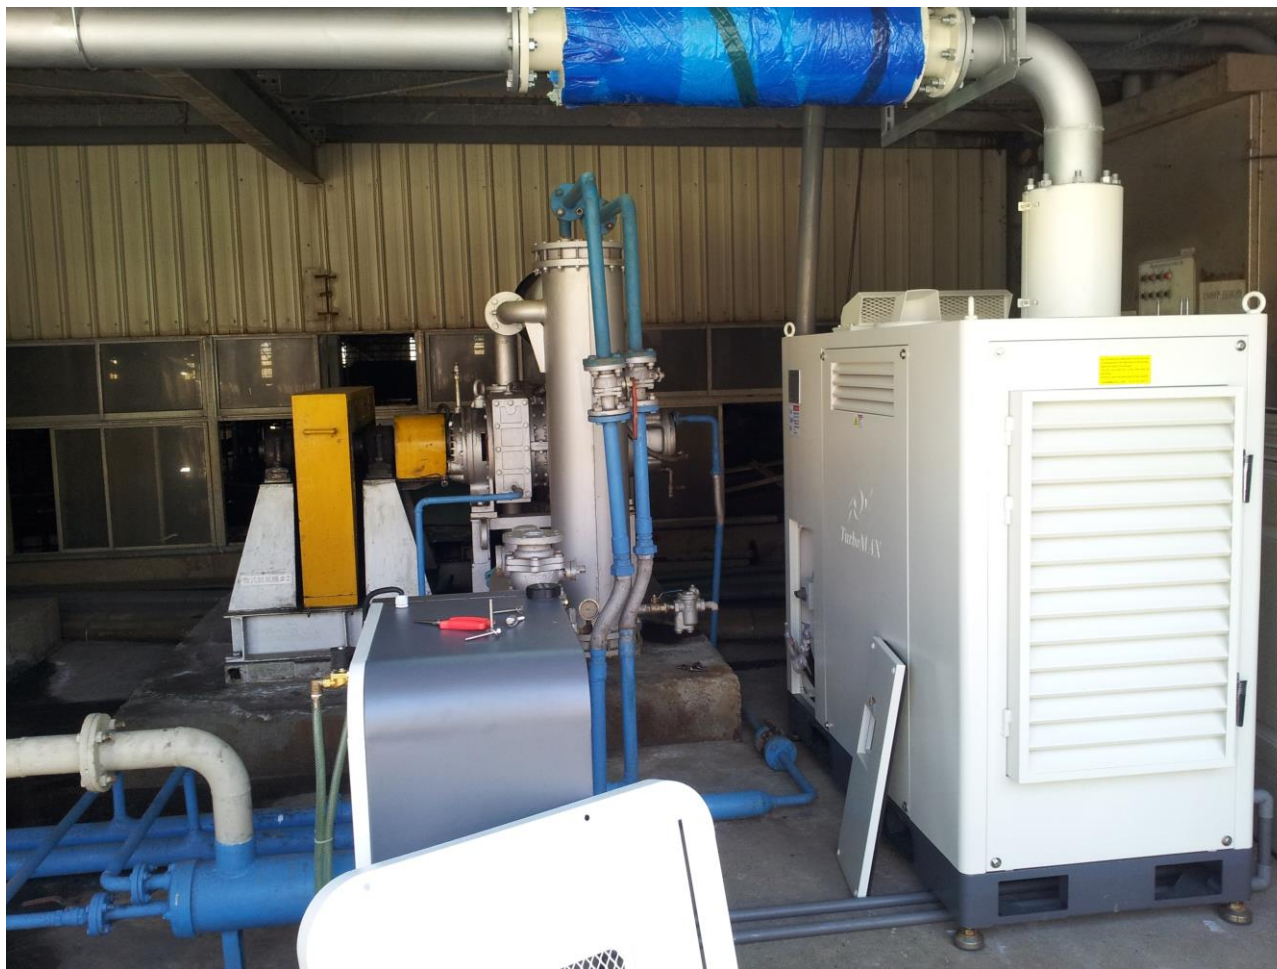
2014年安裝額定馬力100HP的氣浮式渦輪鼓風機，
供應與300HP魯式鼓風機相同的風量以及風壓

2015年安裝第2台額定馬力100HP的氣浮式渦輪鼓風機，
並拆除既有的魯式鼓風機。

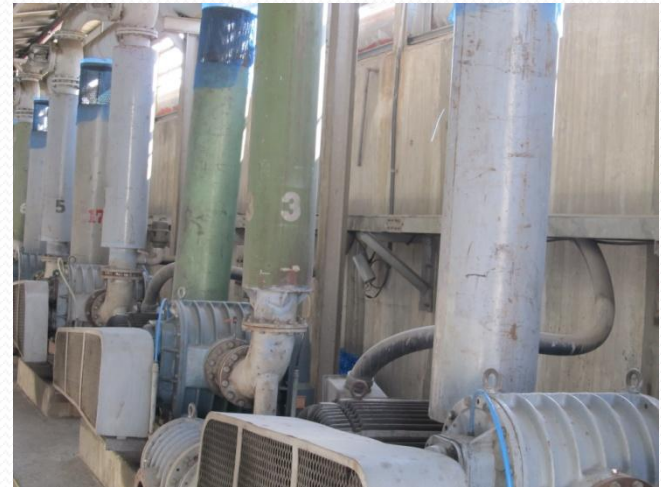
Existing Blower Operation

Type : Roots Blower

55m³/min* 0.6bar* 55kW * 16 units

12 units Working / 4 units Stand-by

Noise : 120db - measured at Entrance

High Vibration, High cost of over-haul

12 Units Working

4Units Stand-by

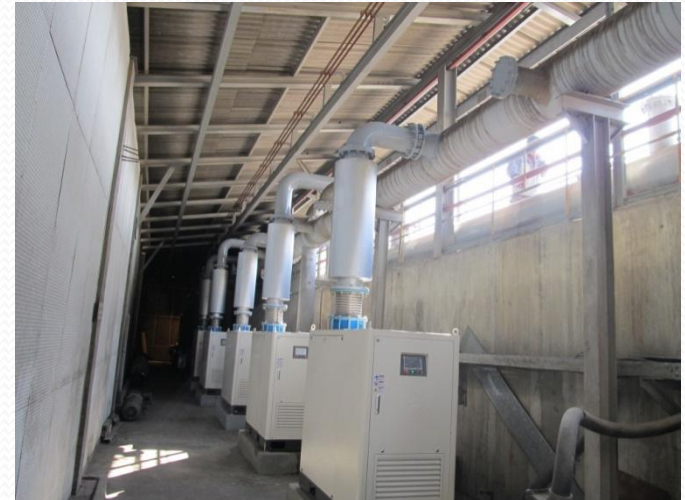
Replacement Blower (March 2011~)

Type : Turbo Blower

105m³/min* 0.6bar* 110kW * 6 Units

6 TB Working / 4 Roots Stand-by

Noise : < 85db - measured at Entrance

Energy Savings realized, No vibration

6 Units Working

4Units Stand-by
