# TURBOMAX BLOWER INTRODUCTION

## 氣浮式鼓風機

今日水處理設備有限  
公司

2020V2

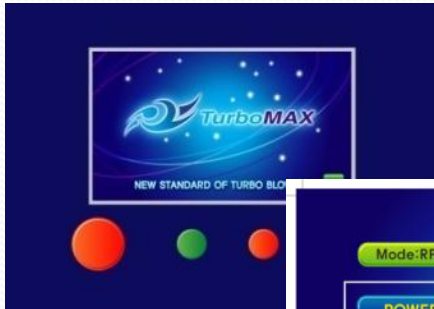
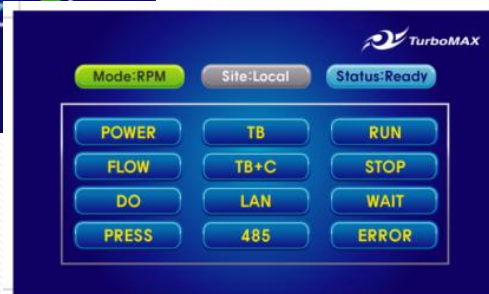
## Core Technology (Controller)

- Direct control of **flow/ pressure** possible through rpm and torque adjustment using high speed motor and inverter. Digital remote control and monitoring is optional.
- Auto Flow Mode
- Auto Power Mode
- Auto RPM Mode
- DO-Link Mode
- Failure Check & Reset

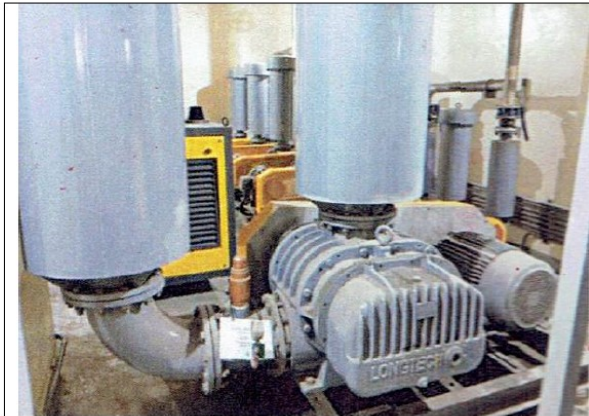
改善前(魯式鼓風機)

案例廠改善前及改善後照片

- 案例廠為國內大型電子廠，目前廢水處理程序曝氣池設置鼓風機，供應曝氣池適當之空氣量，以維持微生物的好氧性分解能力。廠內目前設有1 台 40HP 魯式鼓風機(改善前)及 1 台 40HP 氣浮式鼓風機(民國 107 年新設置)，平常僅開啟 1 台鼓風機使用。針對 2 台不同鼓風機應用在曝氣池之耗能情形進行比較：
- 完工時間：民國107 年
- 效益評估：  
2 台鼓風機規格分別如下所示，因在不同的水池曝氣狀況下，其效益不同，以下分別說明量測評估方式。

形設備式	出風口 截面積 (m <sup>2</sup> )	平均風速 (m/s)	風量 (m <sup>3</sup> /min)	耗電量 (kW)	電壓 (V)	電流 (A)	功率因數 (%)
魯式	0.034	14.96	30.5	34.2	370	61.9	86
氣浮式	0.034	9.42	19.2	18.2	372	28.6	99

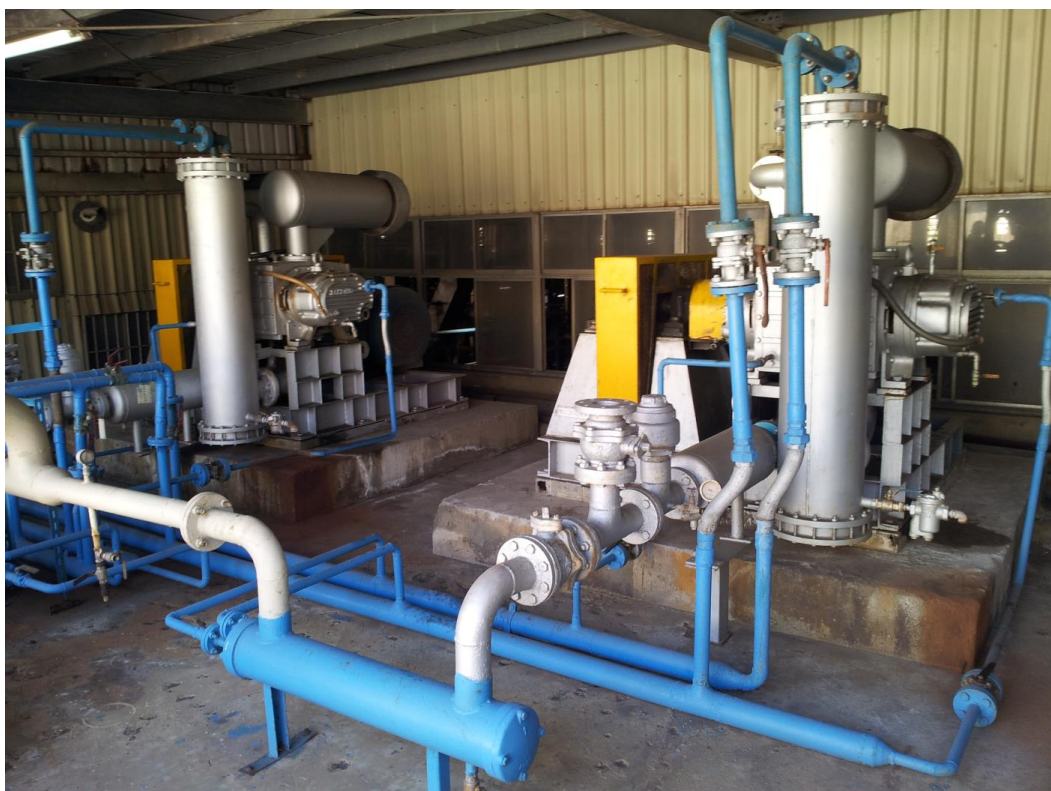
既有魯式鼓風機，需同時運轉300HP才可供應廢水廠需求風量

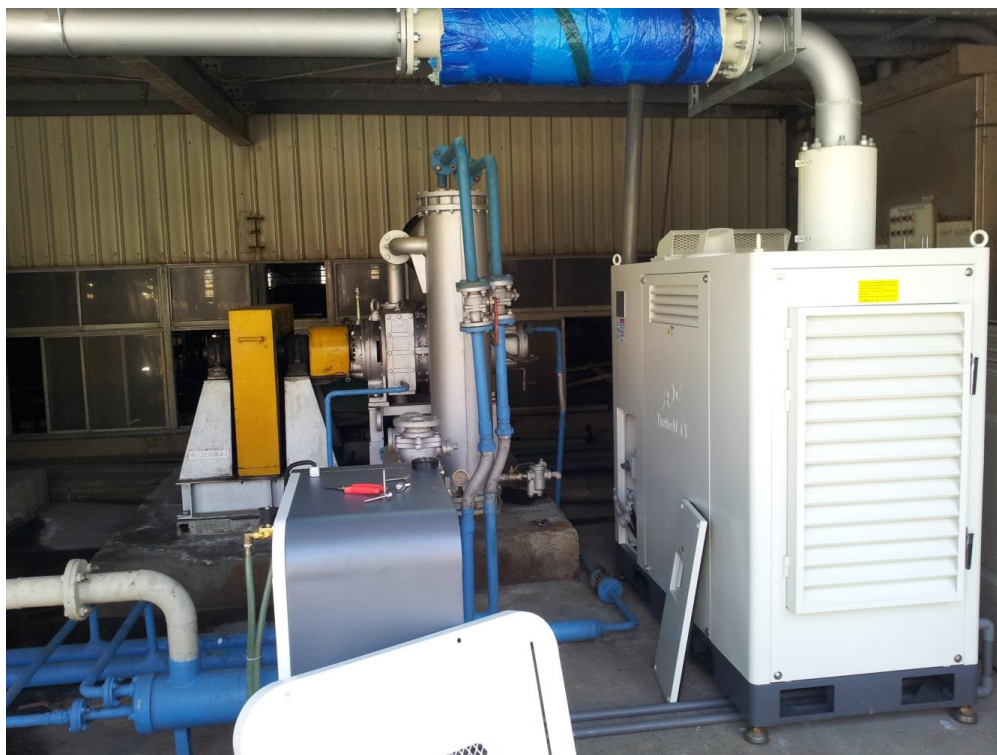
2014年安裝額定馬力100HP的氣浮式渦輪鼓風機，  
供應與300HP魯式鼓風機相同的風量以及風壓

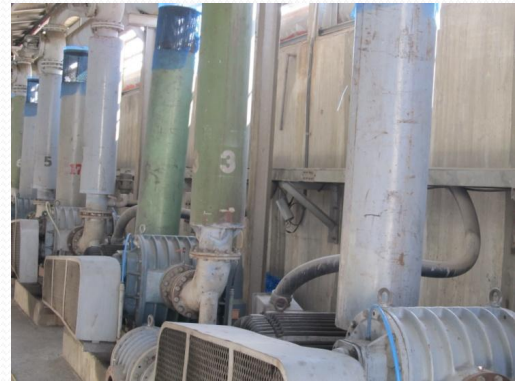
## Existing Blower Operation

Type : Roots Blower

55m<sup>3</sup>/min\* 0.6bar\* 55kW \* 16 units

12 units Working / 4 units Stand-by

Noise : **120db** - measured at Entrance

High Vibration, High cost of over-haul

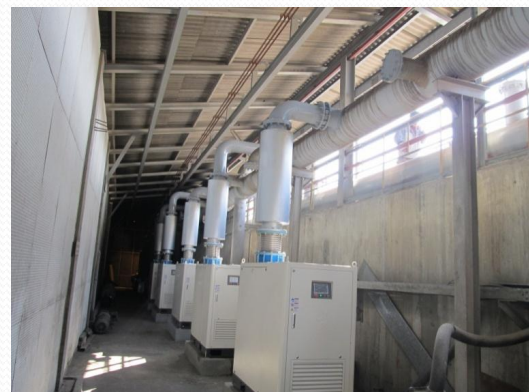
## Replacement

Type : Turbo Blower

105m<sup>3</sup>/min\* 0.6bar\* 110kW \* 6 Units

6 TB Working / 4 Roots Stand-by

Noise : **< 85db** - measured at Entrance

Energy Savings realized, No vibration
